# TRIPOLI EMERGENCY FUND

consolidation of lot 2054 -BT

Volume 6  
Tender Drawings

PROJECT TITLE :  
Consolidation of plot 2054- BT

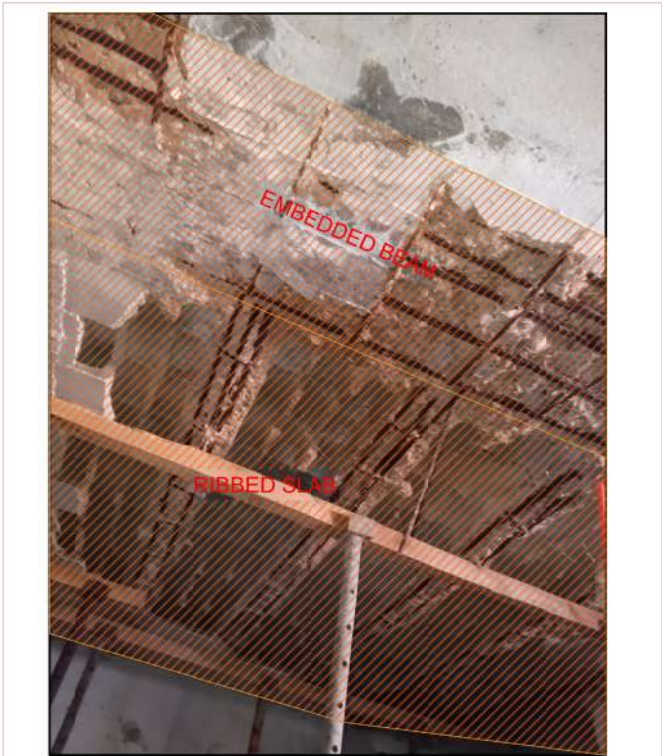
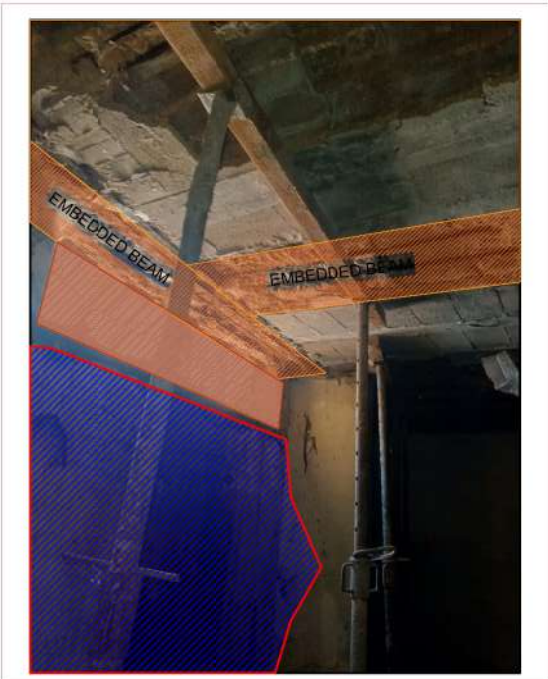
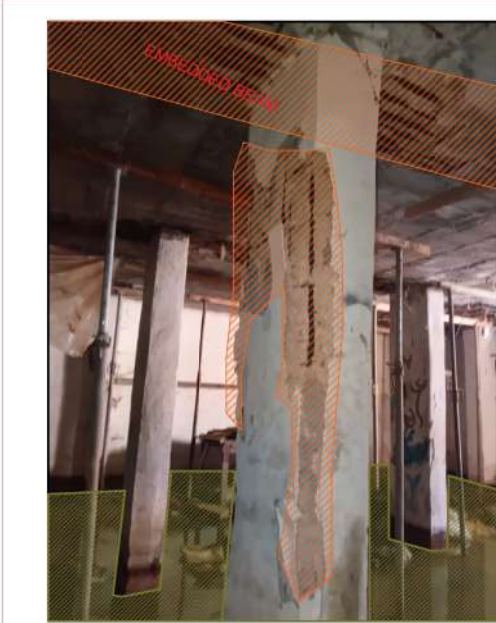
DRG-002

BASEMENT EXISTING STATUS

The basement structural elements are currently experiencing multiple critical defects, including:

- 1- Water infiltration originating from defective sewerage pipes ,failure of waterproofing/insulation layers and improper sealing of the openings( windows).
- 2- Cracks in vertical elements, specifically columns and walls.
- 3- Concrete Deterioration and reinforcement corrosion in slabs, beams, and columns, resulting in reduced effective section capacity.
- 4- Accumulation of contaminated water and debris within the basement, posing both structural risks and health hazards.

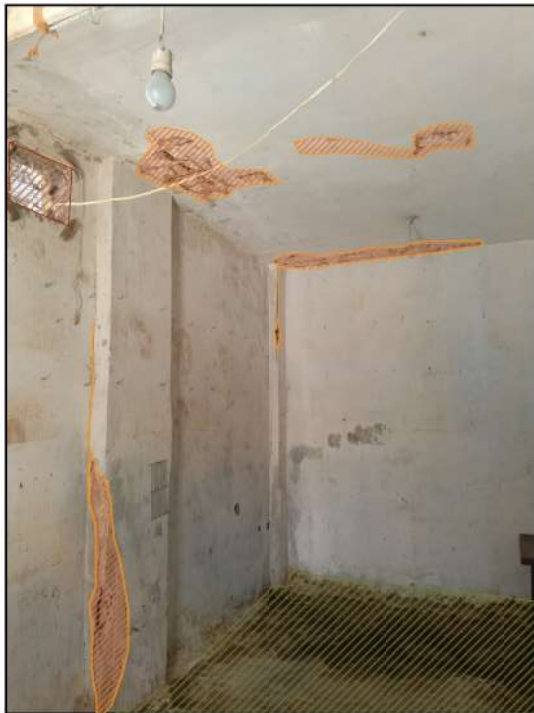
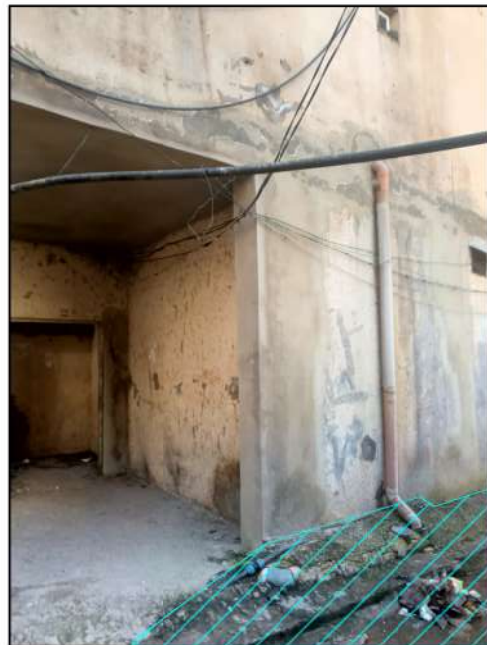
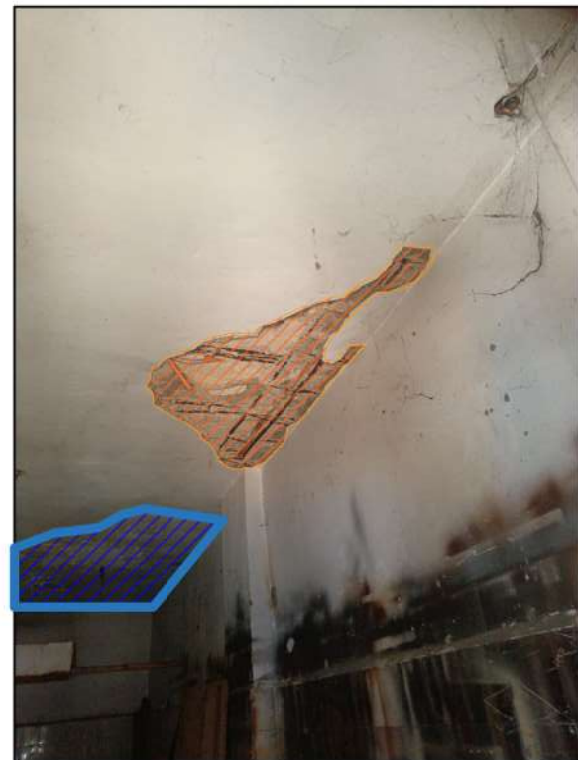
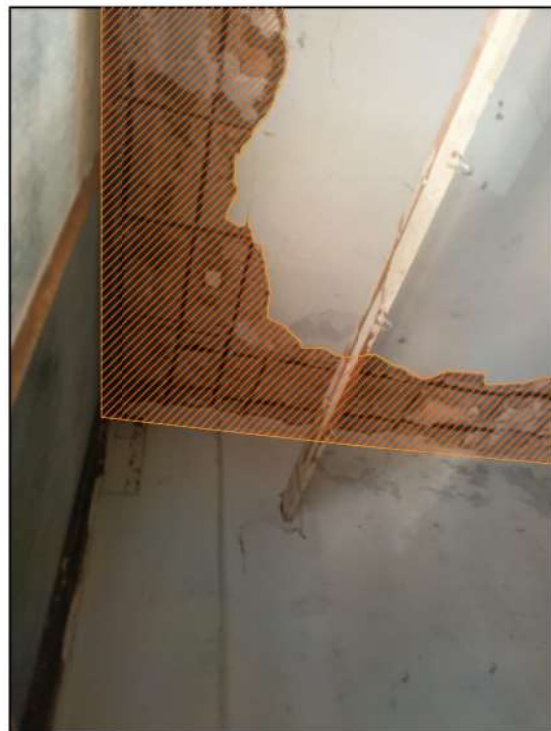
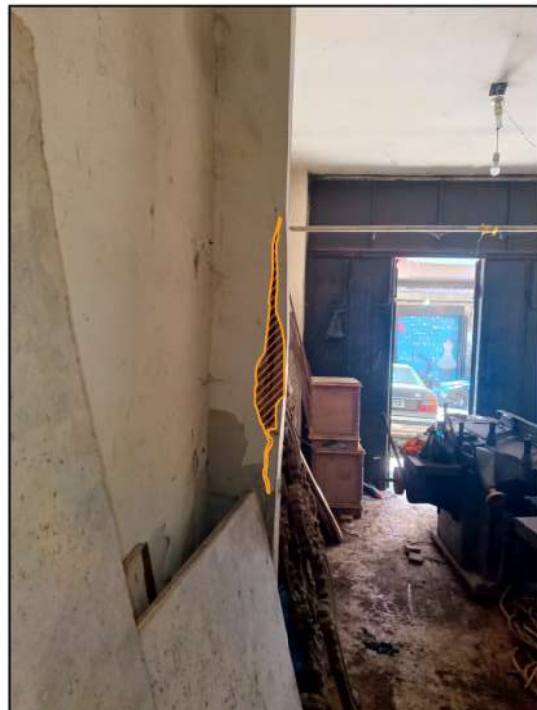
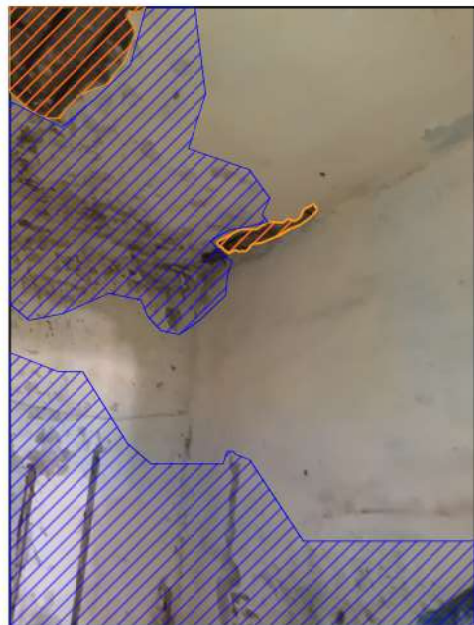
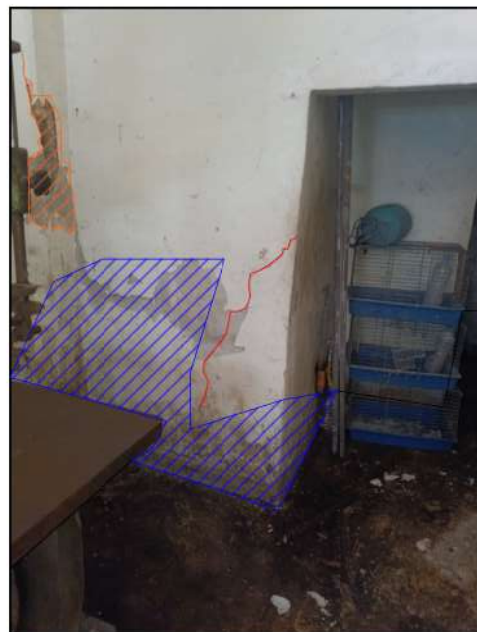
DRG-003

GROUND FLOOR EXISTING STATUS

The ground floor structural elements are currently experiencing critical defects, including:

- 1- Water infiltration due to defective sewerage pipes and failure of waterproofing/insulation layers.
- 2- Cracks in walls, columns, and beams.
- 3- Concrete Deterioration and reinforcement corrosion in slabs, beams, and columns.
- 4- Accumulation of water and debris, contributing to unsanitary conditions and accelerating deterioration.
- 5- Defected doors, resulting in loss of enclosure and increased exposure to environmental factors.

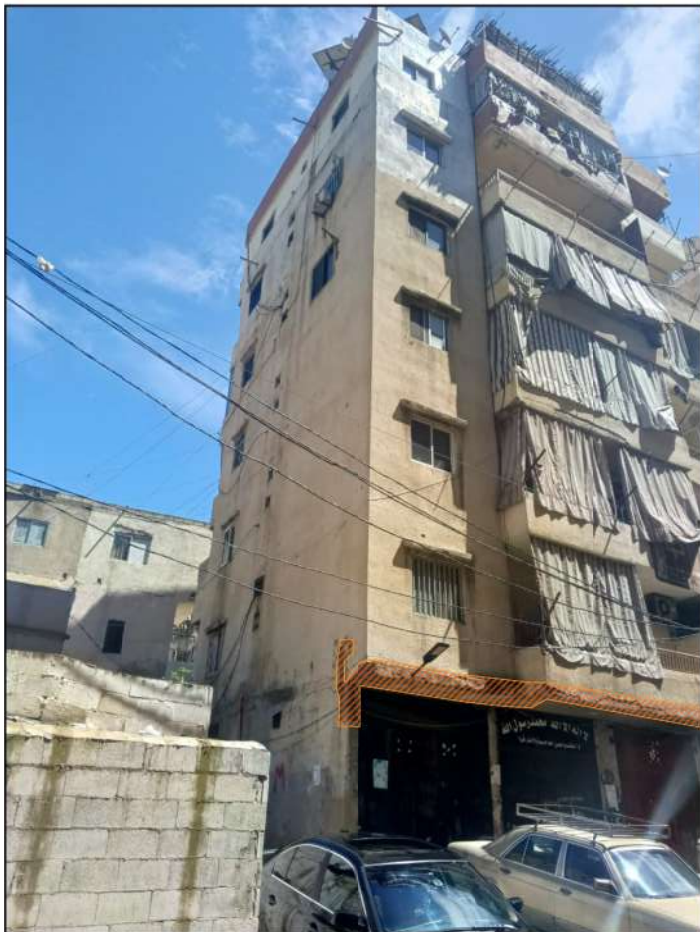
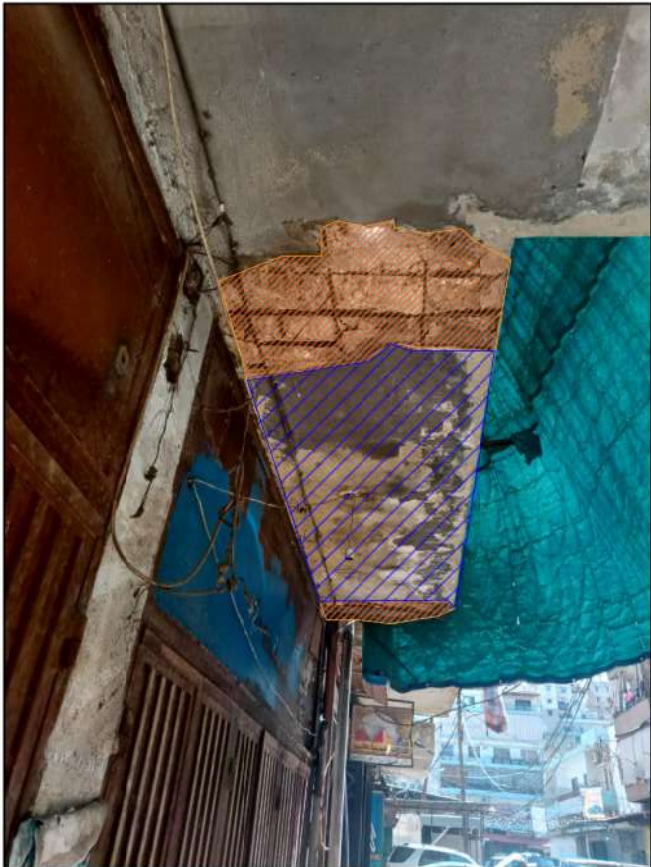
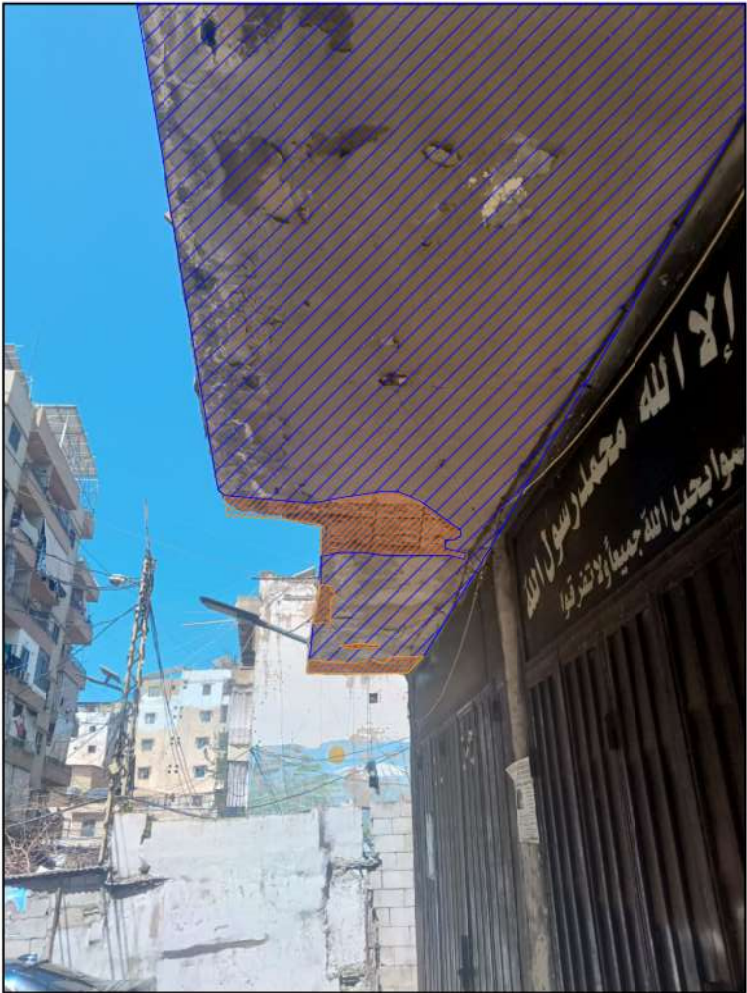
DRG-004

FACADES EXISTING STATUS

The building facades are currently exhibiting significant deterioration and structural defects, including:

- 1- Concrete Detachment and exposed reinforcement, resulting in corrosion and loss of structural integrity.
- 2- Detached finishes and cladding, causing aesthetic degradation and potential safety hazards.
- 3- Saltation and efflorescence, due to prolonged water exposure and poor surface protection.
